Report No. APG-MT-3294

FINAL REPORT ON
PRODUCT IMPROVEMENT TEST

TRUCK, UTILITY, 1/4-TON, 4X4, M151 SERIES WITH
MODIFIED INDEPENDENT REAR SUSPENSION SYSTEM

JULY 1969

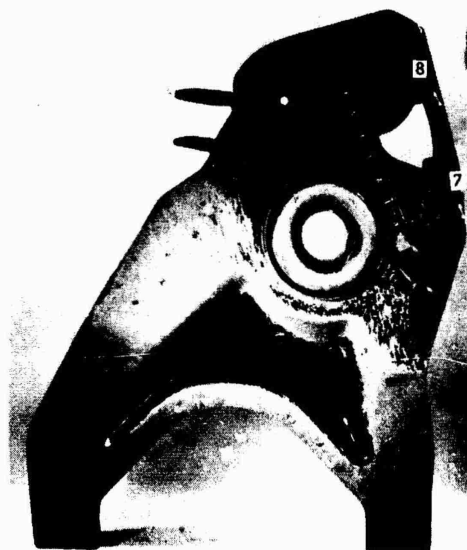
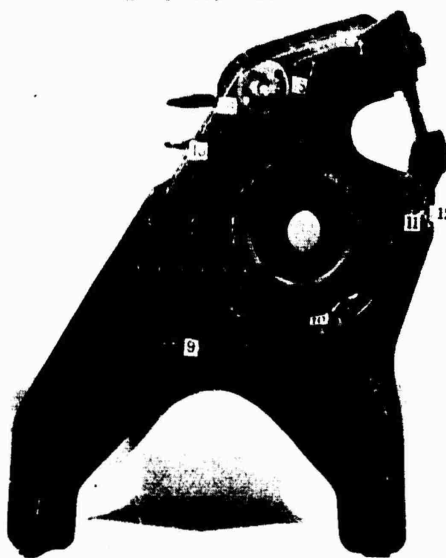
Figure III-38: A Typical Crack Pattern of the M151A1, M718 and M151A1C Rear Suspension Arms is Denoted by the Location of Numerical Numbers Shown on the Rear Suspension Arms of the M151A1C after 10101 Test Miles. Numbers 1 and 9 are Peculiar to the M151A1C. Magnaflux Examination Showed:

<u>Vehicle</u>	<u>No. Cracks</u>	<u>Test Miles</u>
M151A1	9	20433
	16	25276
M718	14	23563
M151A1C	17	5090
	20	10101
	III-22

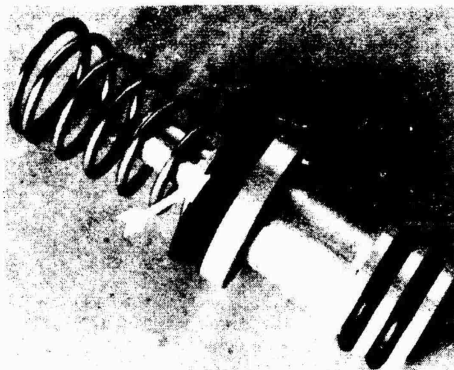
Figure III-63: Arrow Shows Groove in Brake Master-Cylinder Valve on M151A1C after 5090 Test Miles.
